# CHEVROLET

VOLUME 25 JUNE, 1953 NUMBER 6

# **COOLING SYSTEM**

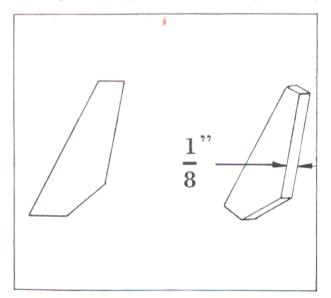
Fig. 4

Where front seat backs on 1953 two door models have taken a "set" to the rear of normal position due to bent center hinge arm supports, they should be re-aligned and reinforced as follows:

- 1. From ½ inch steel stock, cut out two (2) reinforcements using the template shown in Figure 4.
- 2. Remove affected front seat back from the body and place upon a covered bench.
- 3. Remove the seat back side panel and inner finish trim strip.
- 4. Loosen the seat back trim and padding and turn back to clear working area.
- 5. Using the previously made reinforcement as a template, straighten the center hinge arm sup-
